# Optimization of works on an existing dam serving a medium sized hydro plant: Challenges and opportunities

**Matteo Rebuschi**  
Frosio Next S.r.l.  
Via Corfù, 71  
25124 Brescia (BS)  
Italy

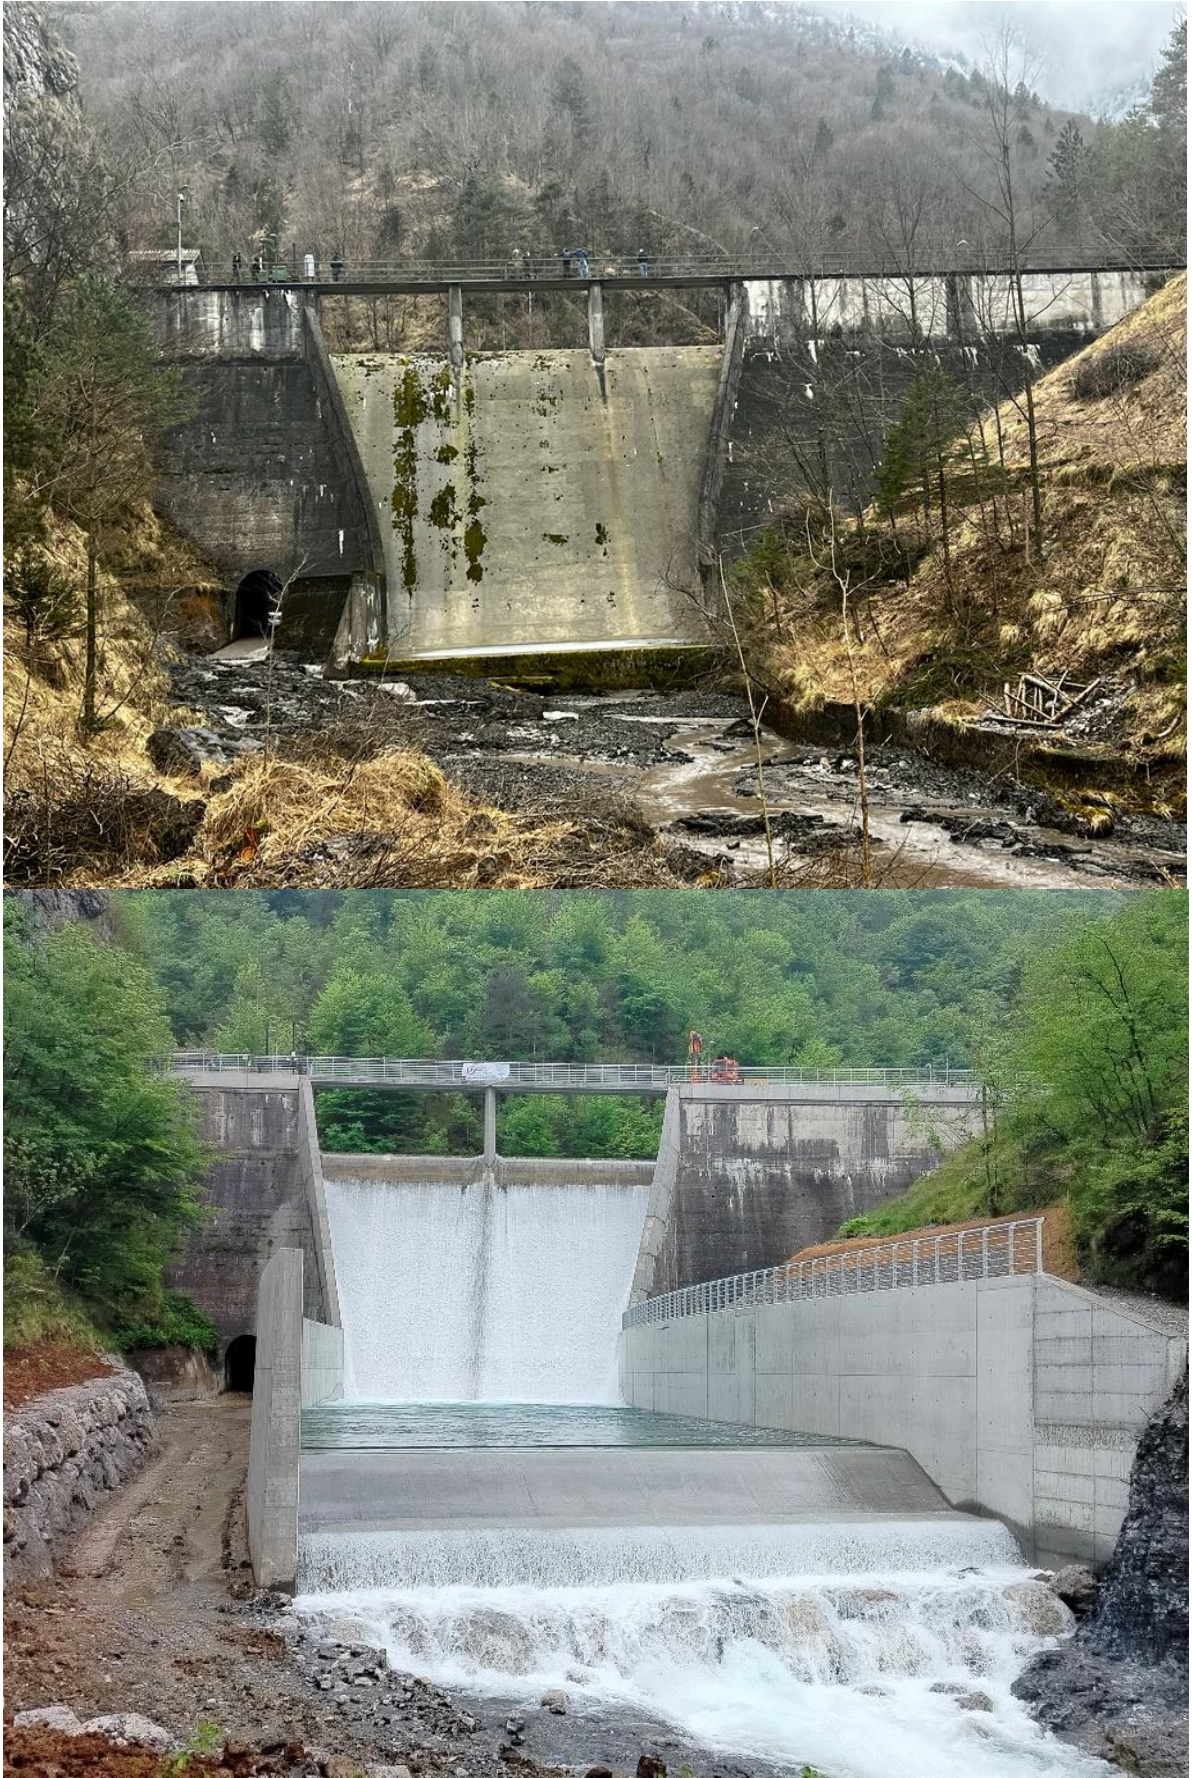
*Figure 1 – Cassiglio dam before (upper image) and after (below image) the works*

The static-functional upgrade of the dam included a concrete gravity block on the upstream face, with a variable thickness depending on the height. Within this new block, an inspection and drainage gallery was built, running parallel to the existing one. The connection between the old and new concrete sections was secured using stainless steel bars, anchored with resin into the existing dam body. The contact surface between the old and new concrete sections was prepared using hydro-demolition where necessary, and a layer of resin was applied to improve the adherence of the contact surface.

The new gravity block was likewise built in monolithic sections, aligned with the corresponding sections of the dam body. A joint was created between each section by inserting a double bitumen-elastomeric membrane. The old dam body and the walkway over the spillway were raised. The old stilling basin was demolished to build a new one suitable for the new millennial flood flow value. At the end of the basin, a step measuring 3.10 m allows for the dissipation of accumulated energy by localizing the hydraulic jump and returning the water to the riverbed at critical velocity. Walls approximately 7 m high contain the fluid flow, even in extreme conditions during a millennial flood. The basin, with a thickness of 130 cm, is securely anchored to the bed via stainless steel bars grouted 120 cm into the riverbed's rock, arranged in a quincunx pattern with a 150 cm spacing. The project also included the replacement of the bottom outlet gate and its associated equipment (hydraulic power unit, accessories, switchboards, and automation).

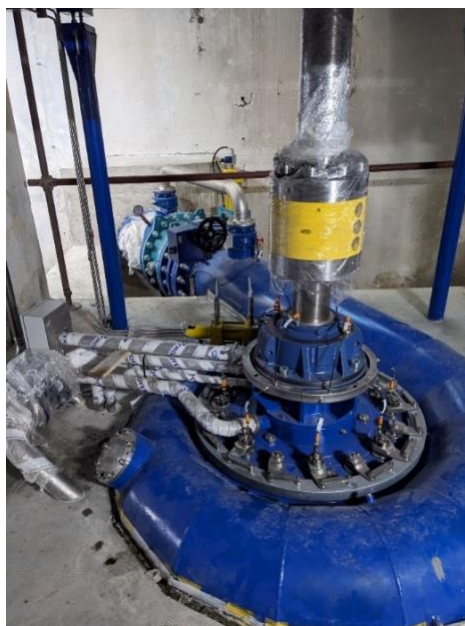
Figure 2 – Francis turbine – Cugno-Brembo Concession

The units of the Cugno-Brembo Concession were replaced with similar units, each consisting of a vertical-axis Francis turbine directly coupled to a synchronous generator. The turbine's maximum flow rate was increased from 1.25 m<sup>3</sup>/s to 1.42 m<sup>3</sup>/s per unit. The characteristics of the two units are as follows:

| • Type | Vertical-axis Francis |
| • Maximum discharge | 1.42 m <sup>3</sup> /s |
| • Head | 100.9 m |
| • Power | 1299 kW |
| • Velocity | 1000 rpm. |

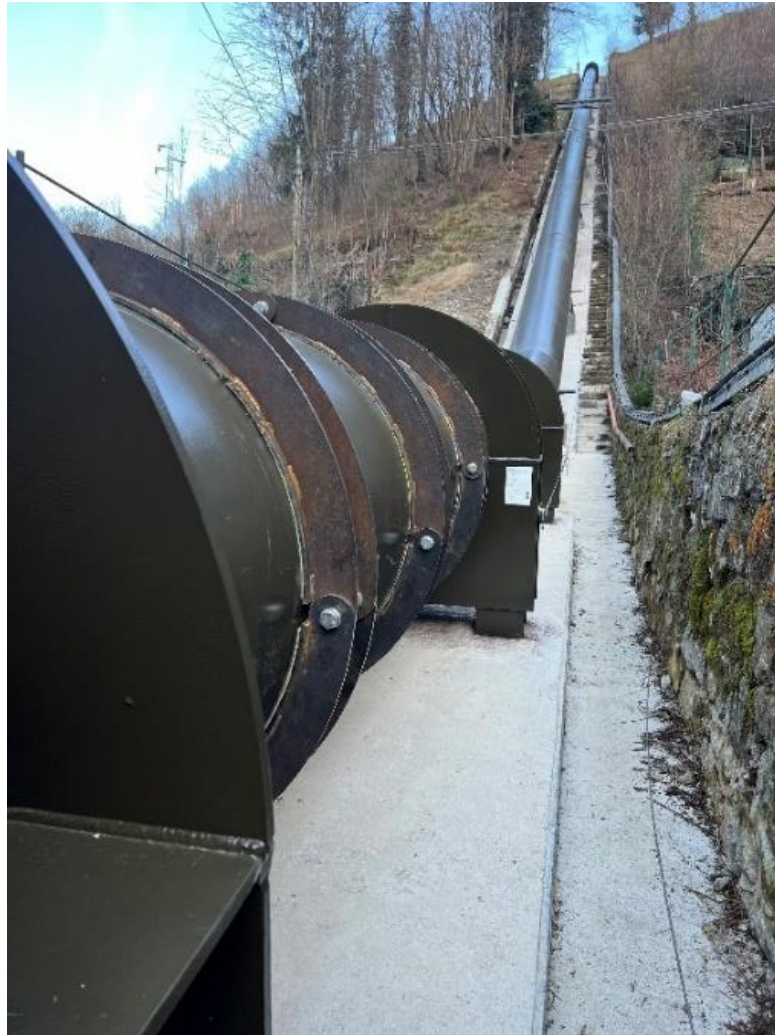
*Figure 3 – Cugno-Brembo penstock*

- The first section (upstream) is an underground reinforced concrete pipe with a diameter of 1.36 m, a length of 239 m, and an average slope of 13%.
- The second section (downstream) is a steel pipe with a DN1200 diameter, a length of 172 m, and an approximate slope of 60%.
-

The replacement of the existing pipe with a new DN1200 steel pipe was limited to the last above-ground section. The new penstock rests on new steel saddles set on small concrete slabs and is equipped with exposed anchor blocks fitted with clamps.

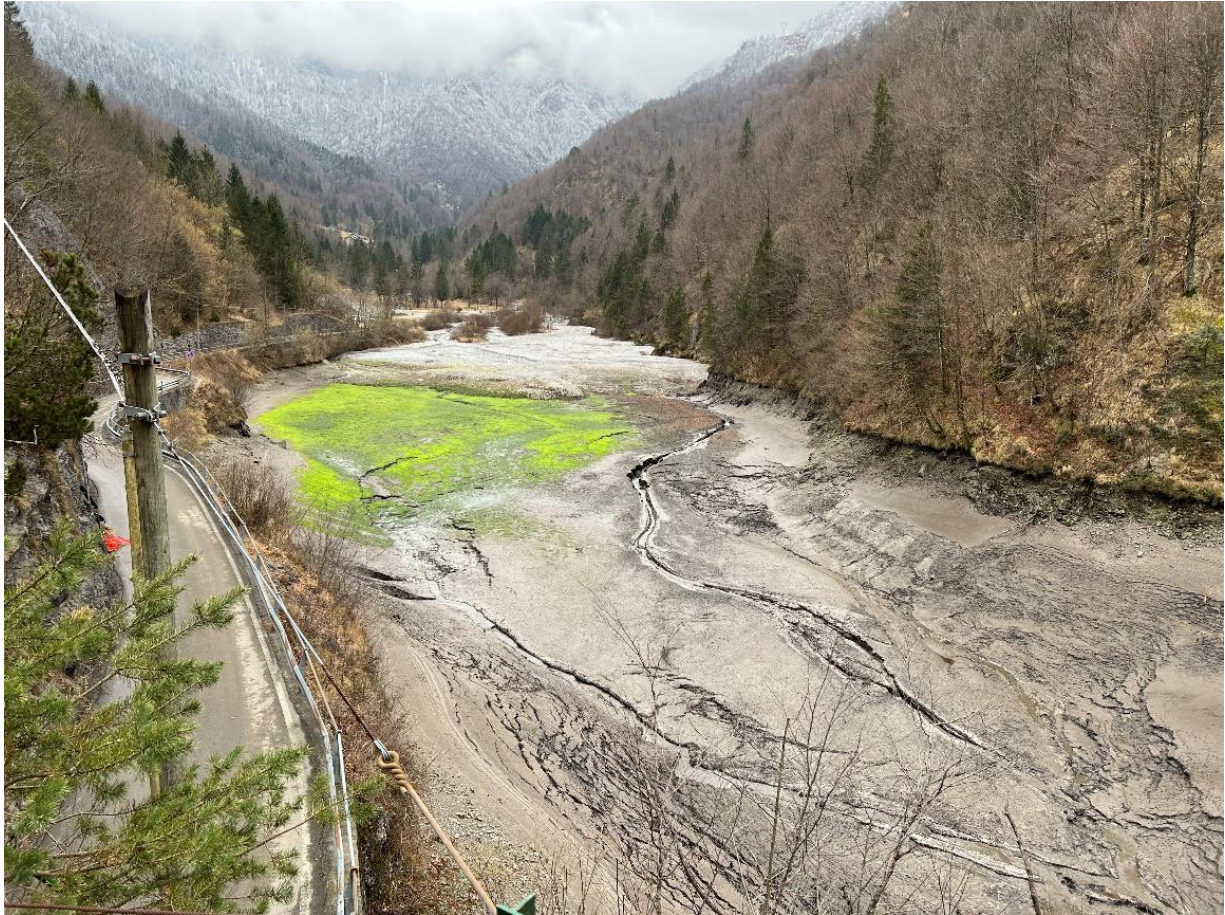
*Figure 5 – View of the lake bottom after emptying*

The Cassiglio reservoir has an active storage capacity of 56,000 m<sup>3</sup> at the maximum regulation altitude (626 m a.s.l.) and a total storage capacity of 81,000 m<sup>3</sup>; over the years, the accumulation of sediment has reduced these volumes..

For this reason, an intervention of removal of the sediments was planned. Therefore, in conjunction with the necessary work on the dam, 46,600 m<sup>3</sup> of sediments were also removed to recover the active storage capacity. Heavy-duty trucks with three-axle trailers were employed to remove the sediments; each trailer has a gross vehicle weight of 26 tons, which is able to transport approximately 15-18 cubic meters of material, consisting primarily of gravel and silt. In total, approximately 2750 haulages were required to remove all the required volume of sediments.

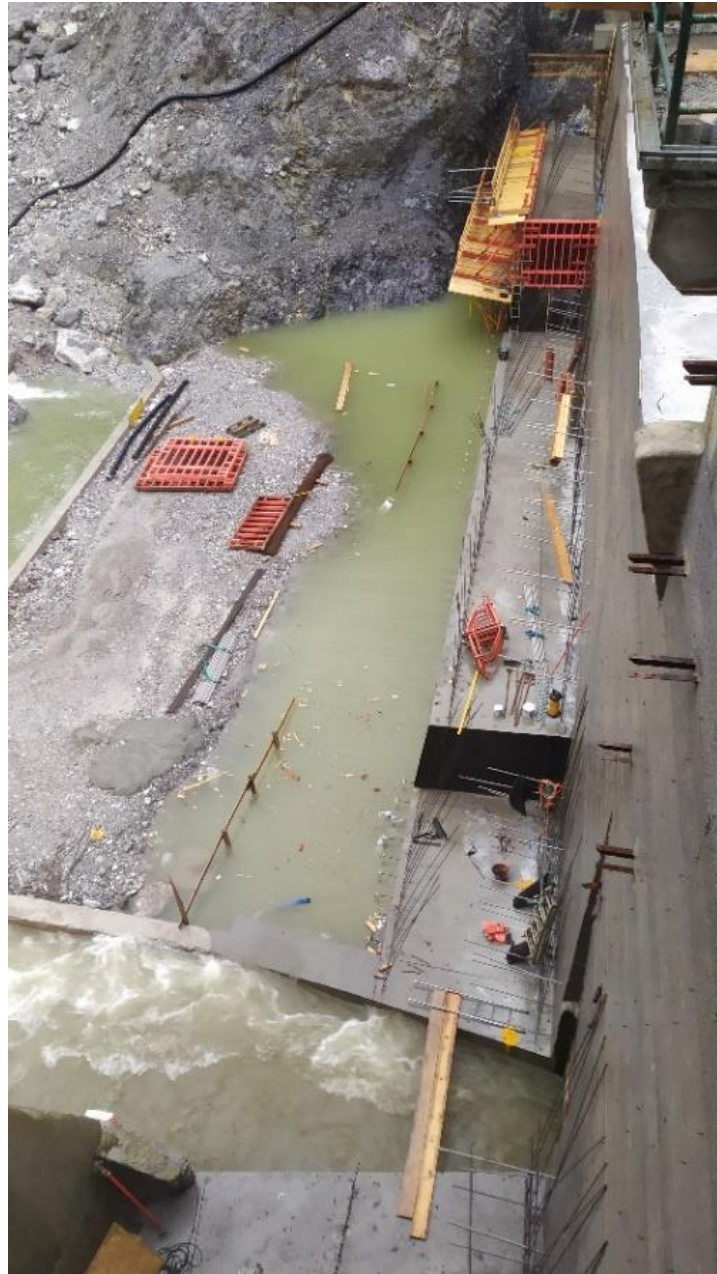
The weather conditions stopped the works on the dam many times. Intense precipitation exceeded the flow capacity of the bottom outlet, resulting in multiple floods. These floods particularly affected the work site at the base of the dam, which lacked a natural drainage path due to being situated below the bottom outlet level. To manage the water in this area, various pumps were employed.

*Figure 8 – Flood in the upstream dam site (with the firsts dam segments)*

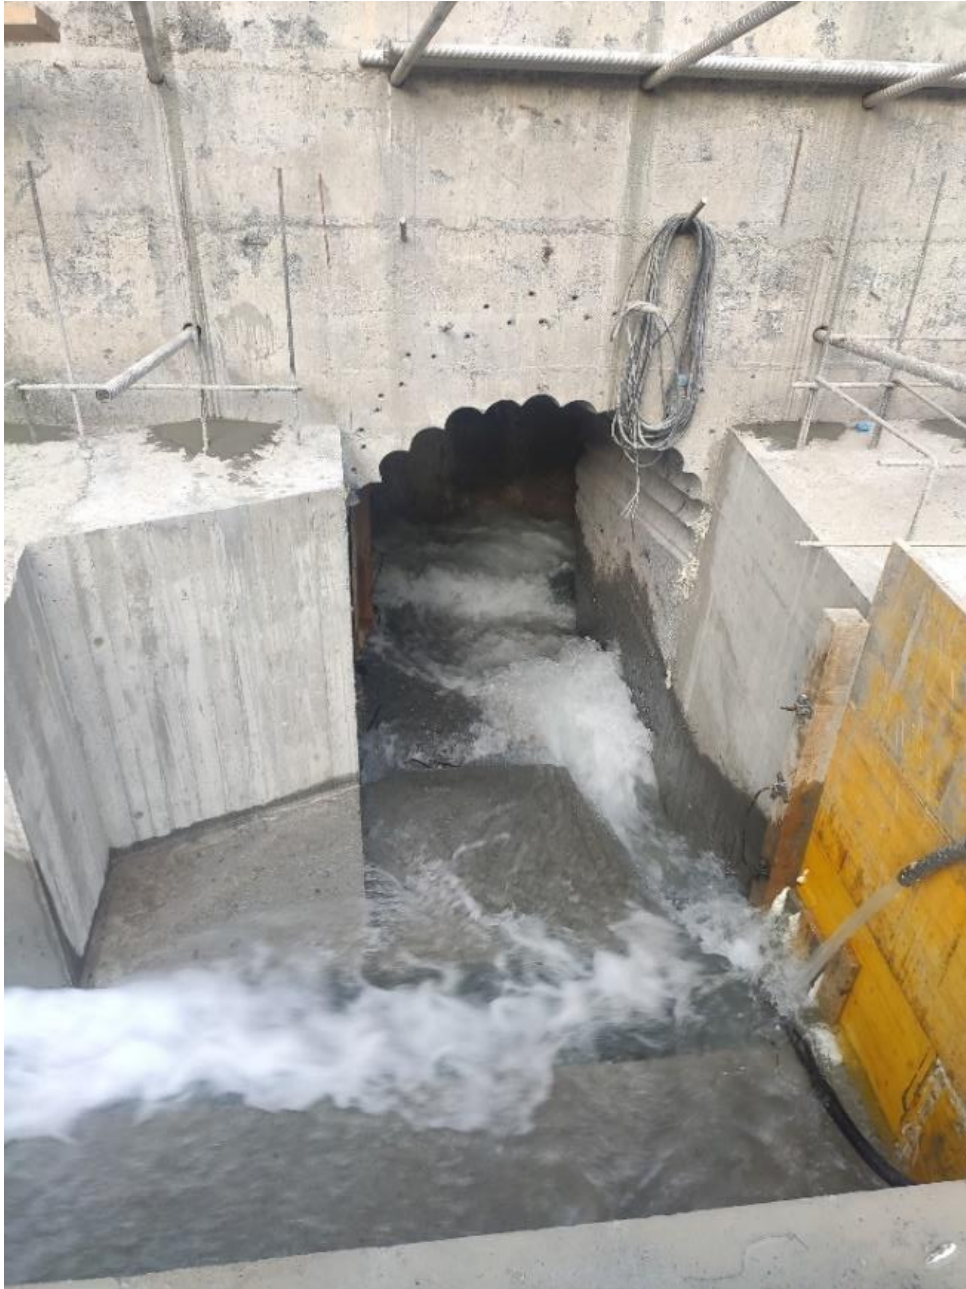
*Figure 9 – The connection of the drainage tunnels of the dam*

The concrete casting schedule was planned based on the results of pre-qualification tests. These tests showed that the formworks could be stripped after just two days of casting due to the concrete's high resistance, allowing for another casting to be done soon after. Moreover, the formworks could be easily moved and installed with a crane, speeding up operations and making it possible to build one block on top of another every 2-3 days. For the construction of the new bottom discharge, water flow was managed by diverting it through the dam's drainage tunnels.
